Dodge vs Hornet

By Lt. Paul Brotze

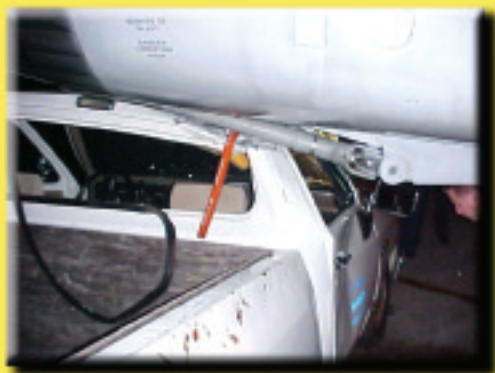
The damage doesn't look too bad from the rear.

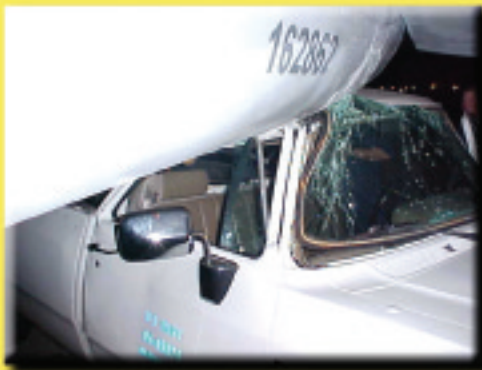
This shot of the Dodge pickup's cab shows the force of the crash.

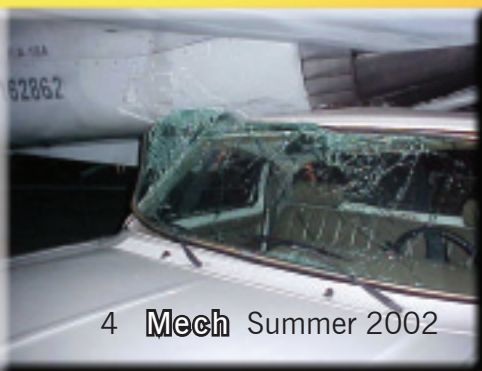
The Hornet fared well, despite the truck's damage.

Two ATs doing wire checks on that aircraft had watched as the truck backed down the ramp. Until the collision, they assumed someone was behind the wheel. Afterward, other maintainers ran over, secured the engine, and began to assess the damage. The bed of the truck had passed beneath the aircraft, just below the tailhook. The cab, which sustained the bulk of the damage, had crumpled like an eggshell when it hit the aircraft's keel. In this Dodge vs. Hornet battle, the news was good for the FA-18. The jet suffered only superficial paint damage to a panel. The hook was examined by AIMD and was returned to service.

As with any near-disaster, we learned a few lessons. The truck's transmission may not have been engaged fully, meaning it could have been human error or mechanical failure. We just don't know. Although the specific cause is unknown, a little timely ORM would have prevented this collision. If the AO3, for one second, had imagined the worst consequence of leaving that vehicle parked on a hill, with engine running, parking brake disengaged, and surrounded by a ramp full of aircraft and maintenance personnel, he certainly would have taken another second to secure the engine and set the brake. It's that simple.
